# **2023 CAPITAL REPAIR AUDIT OF CLEVELAND BROWNS STADIUM FOR THE CITY OF CLEVELAND**

PREPARED BY OSBORN ENGINEERING

February 22, 2024

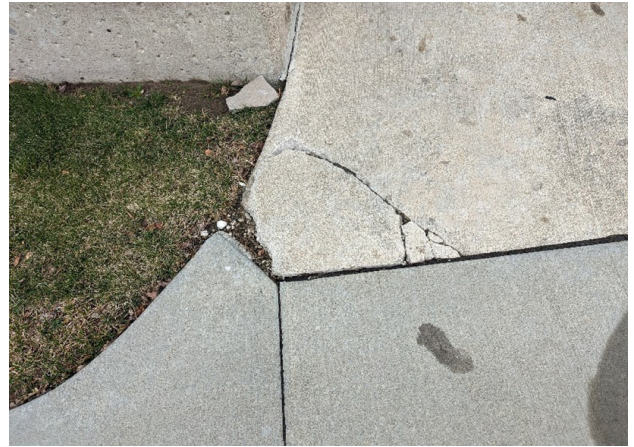
Photo C1 – Typical Cracked Concrete

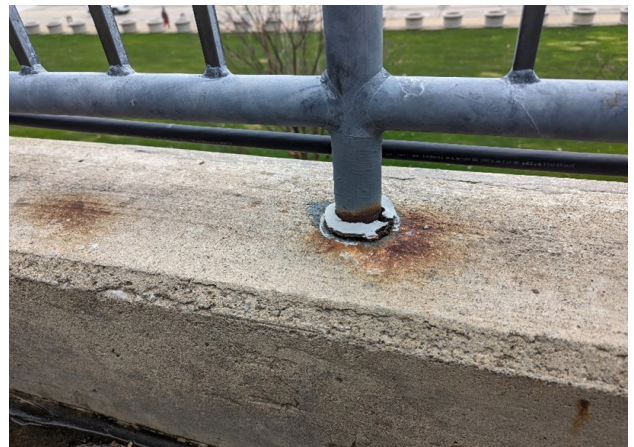
Typically sealant materials exposed to the environment and UV can be expected to have a useful service life of 7 to 10 years. As a result, the continual repair of such joints can be expected annually for the hardscaped areas surrounding the stadium. We did observe failed joint sealants in a variety of locations as anticipated.

Photo C2 – Typical Failed Sealant at Guardrail Post

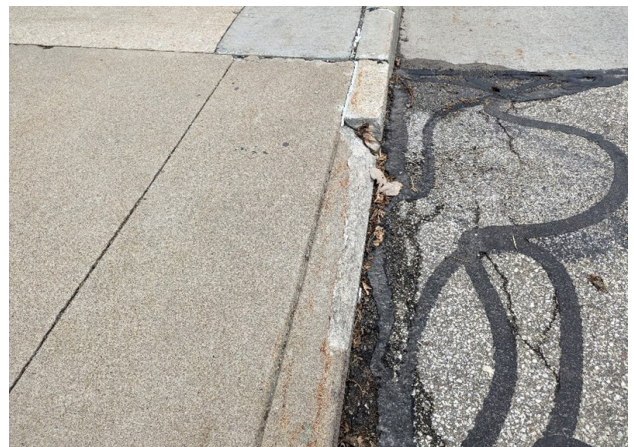
Photo C3 – Typical Failed Curb

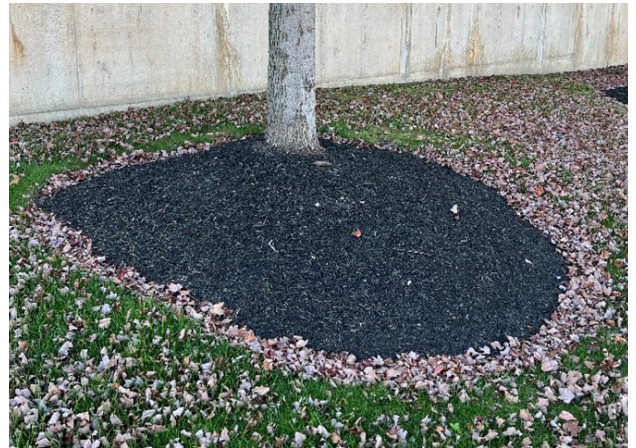
Photo L1 – Over-Mulching Around Trees

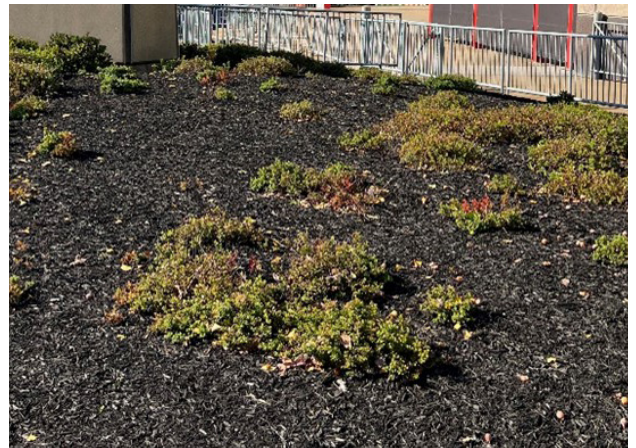
Photo L2 – Little Princess Spirea in Poor Condition

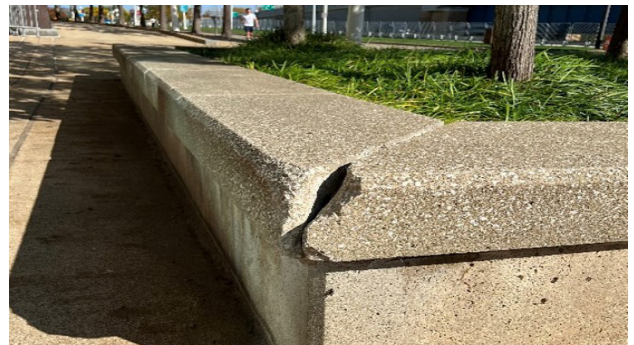
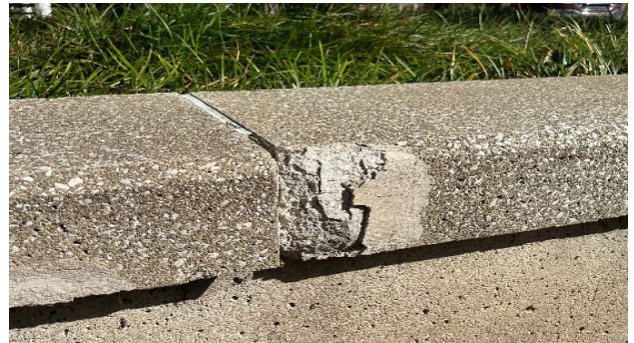
Photo L5 – Planter Bed Precast Concrete Coping In Poor Condition

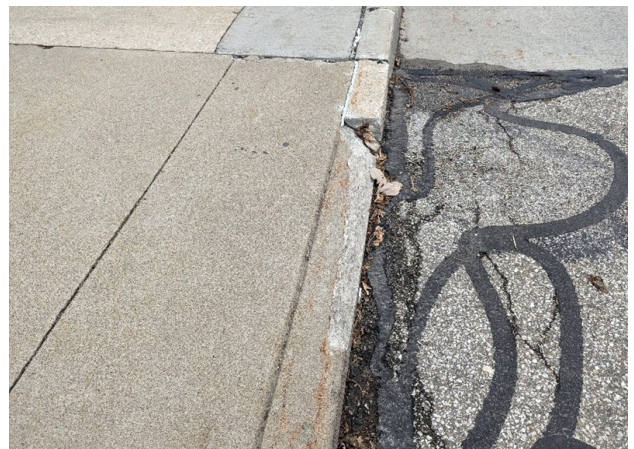
Photo L6 – Curbed Plant Bed – In Poor Condition

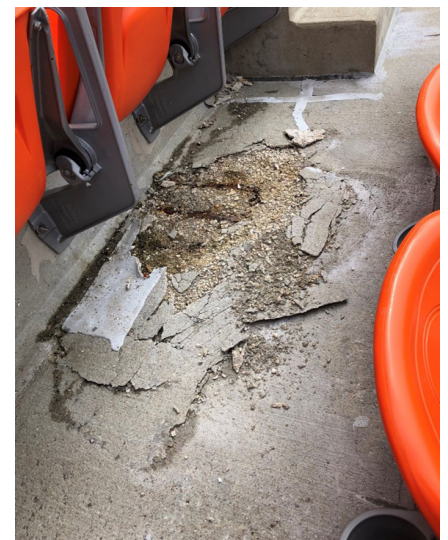
The observed concrete spalls are found in varying locations including tread & risers, vomitory walls, and curbs. In general, the areas to be patched are partial depth and predominantly a result of the corrosion of the embedded steel reinforcing. **See Photo S1.** Some areas of failed concrete can be found immediately adjacent to a failed joint sealant. The infiltration of water into a failed sealant allows for additional moisture to advance to the reinforcing steel accelerating overall deterioration.

Photo S1 – Typical Spalled Concrete

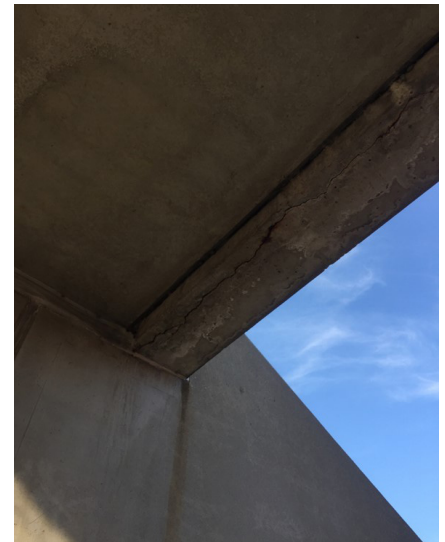
Photo S2 – Typical Cracked Concrete

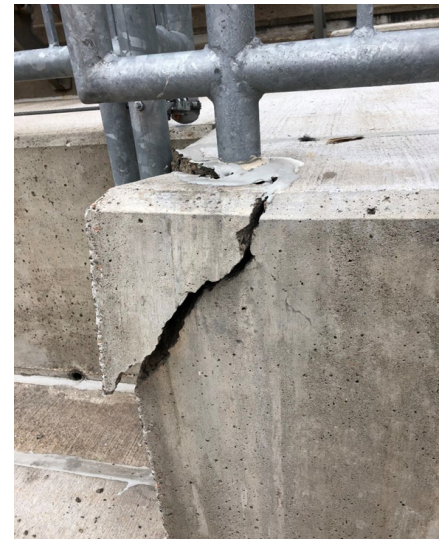
Photo S3 – Typical Concrete Damage at Guard Rail Post

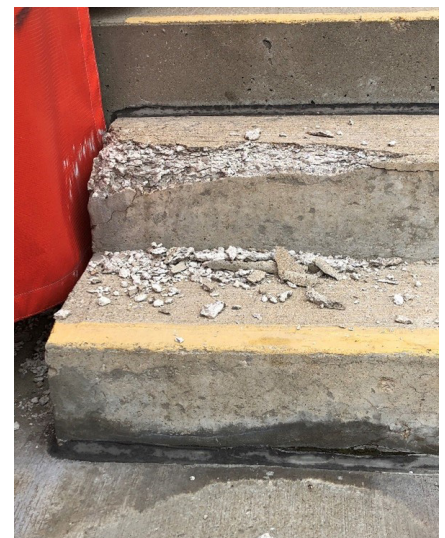
Photo S4 – Typical Deteriorated Aisle Step

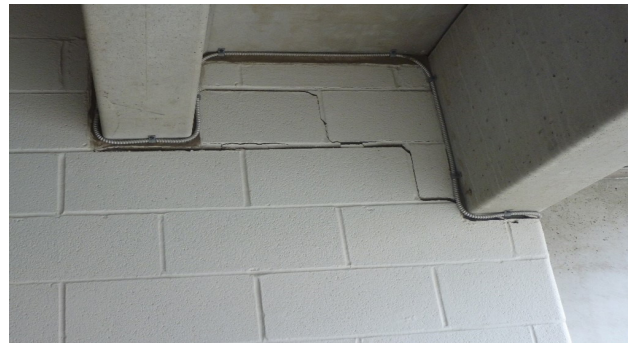
Photo S5 – Typical Masonry Cracking at Vomitory Wall

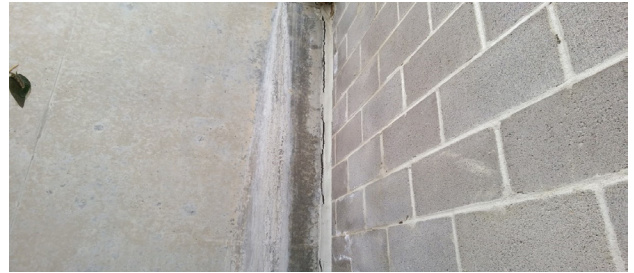
Photo S6 – Typical Failed Backer Rod & Sealant Joint

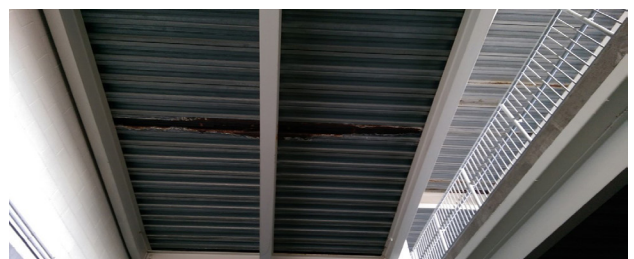
Photo S8 – Typical Corroded Metal Floor Deck at Ramps

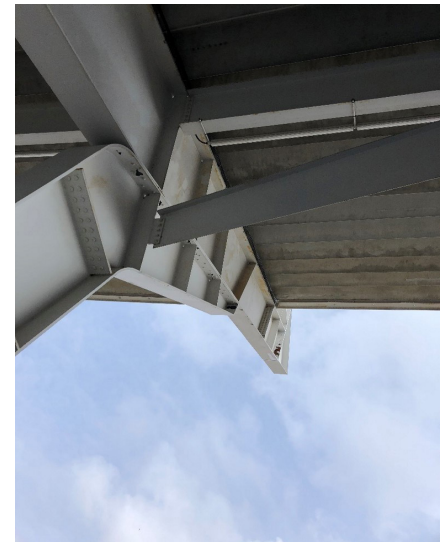
Photo S9 – Typical Surface Corrosion on Structural Framing Member

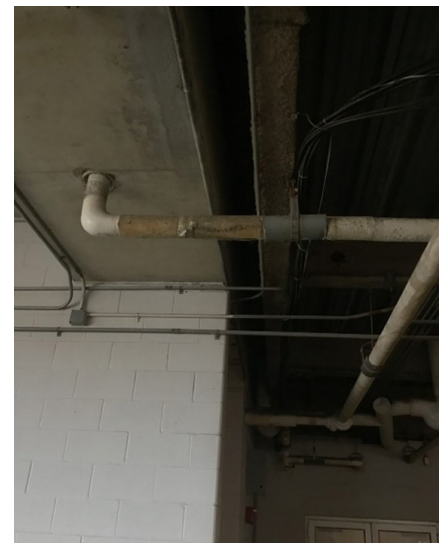
On the Main Concourse, it was observed that the paper jacket on several domestic water branch lines was deteriorating from being exposed to the weather. This exposed the fiberglass insulation reduces its effectiveness. In addition to the deteriorating paper jackets, several pipe hangers were observed to be rusted over presenting a risk of failure in the future. **See**

Photo P1 – Domestic water insulation with worn off paper jacket

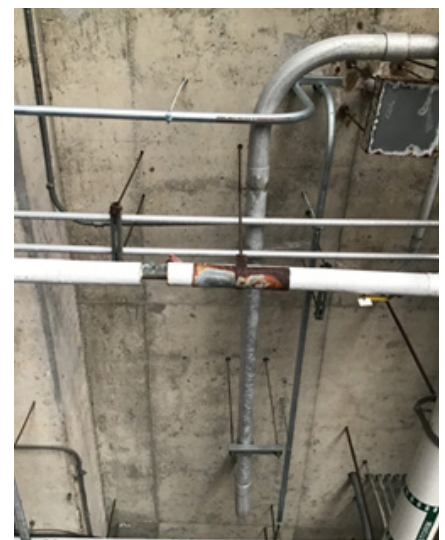
Photo P2 – Deteriorating pipe hangers

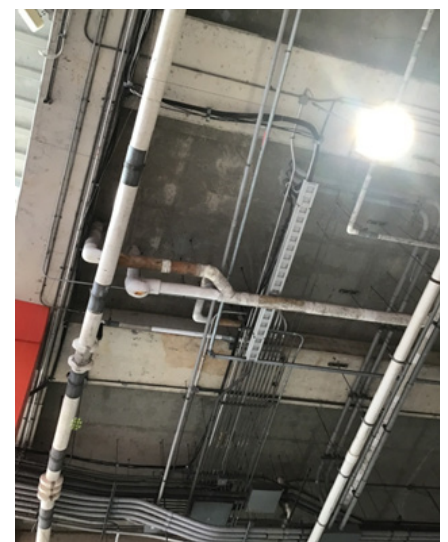
Photo P3 – Deteriorated storm pipe insulation

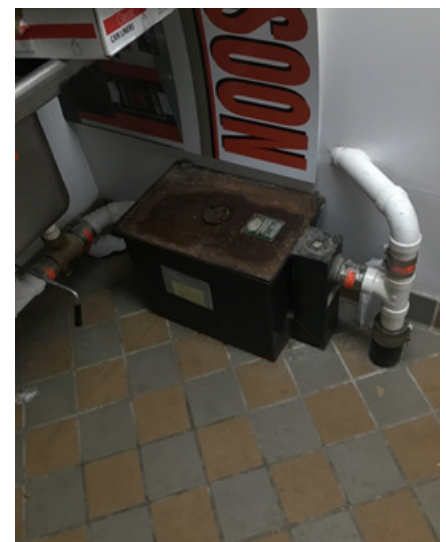
The grease traps are heavily used and often handled incorrectly by concession staff. Concession staff are comprised of volunteer workers who, in some cases, are not aware of food waste that cannot be drained into the sanitary system. In many cases, as reported by Browns facility staff, large amounts of solid food waste are drained into the kitchen

Photo P4 – Rotted grease trap

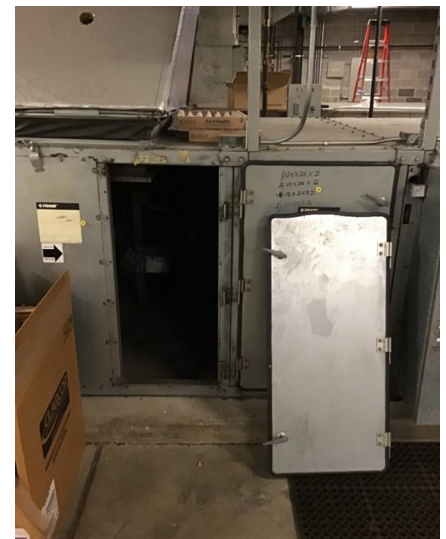
Photo M1 – Door Off The Hinges  
On Ahu

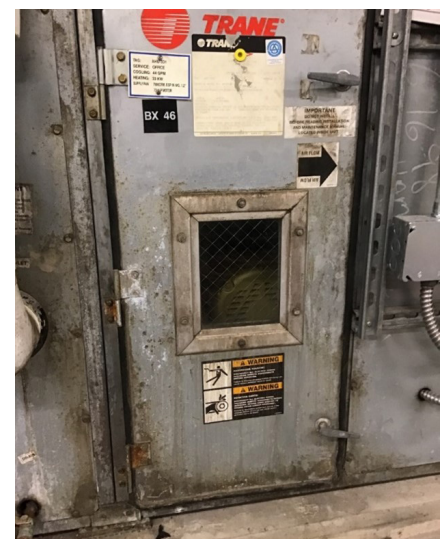
Photo M2 – Ahu Deterioration

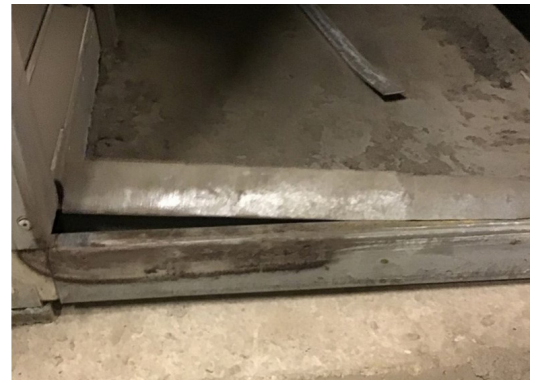
Photo M3 – Edge And Door Seals Worn On Ahu Access Door.

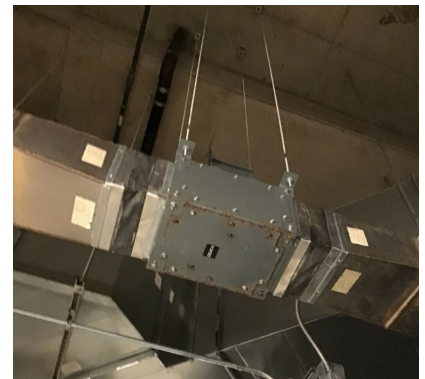
Most of the roof and in-line mounted exhaust fans for restrooms, grease, dishwashers are past their expected life of 20 years per the ASHRAE equipment life expectancy chart. **Refer to Photo M5** for a grease fan that has surface corrosion.

Photo M5 – Grease Fan Corrosion

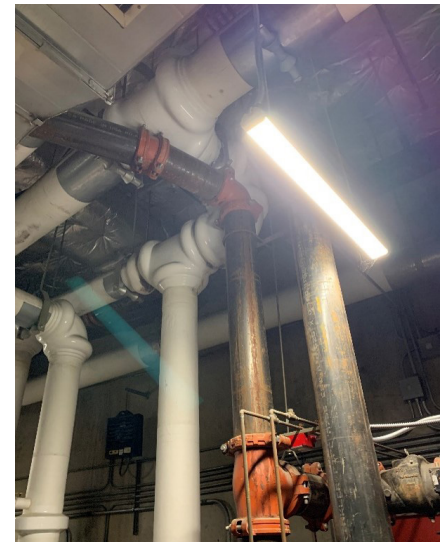
Photo FP2 – Main 12” Incoming Fire Service Lines

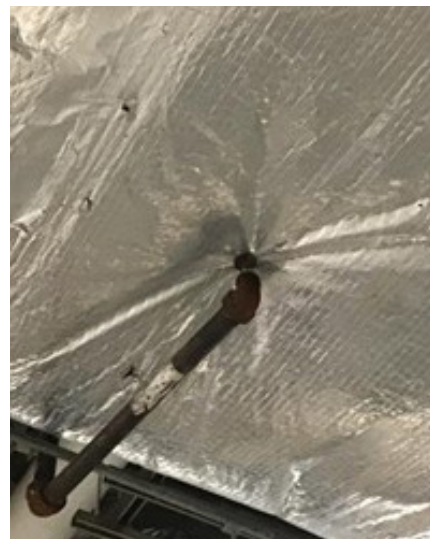
Photo FP3 – Duct Insulation  
Sagging Interfering With Sprinkler  
Deflector Clearance.

Regarding the sprinkler deflector clearance issues, it is recommended

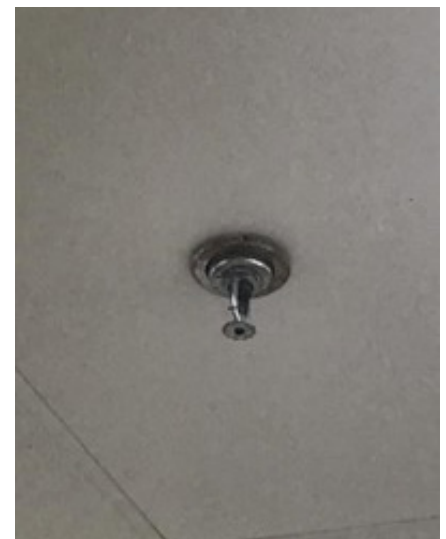
Photo FP5 – Main Concourse  
Typical Sprinkler Head Visible  
Corrosion

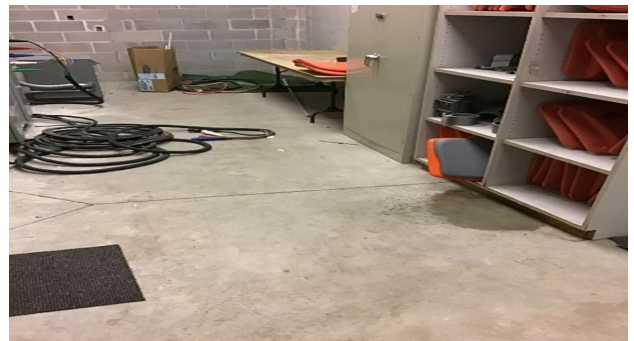
**See Photo E1.** It is apparent the equipment hasn't been maintained on a regular schedule, though the main Switchgear was last serviced in September 2022 by Resa Service (2018 prior to that). Equipment showed signs of "wear and tear" such as branch circuit panels in the

Photo E1 – Water Leak Close To Panels And Cam-Loks.

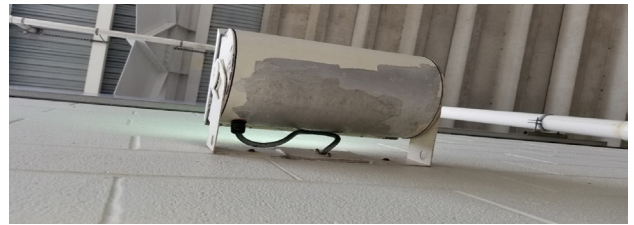
Photo E8 - Typical Wall Mounted Hid Fixture Showing Corrosion.

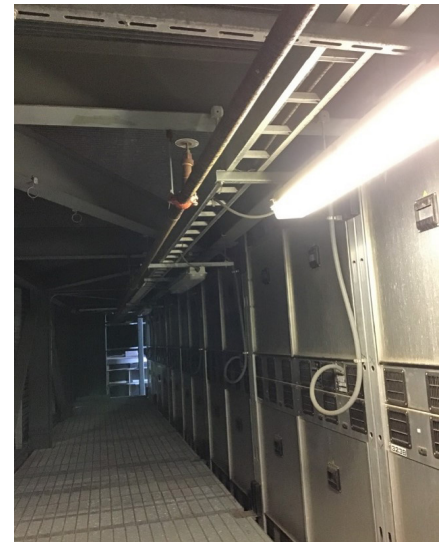
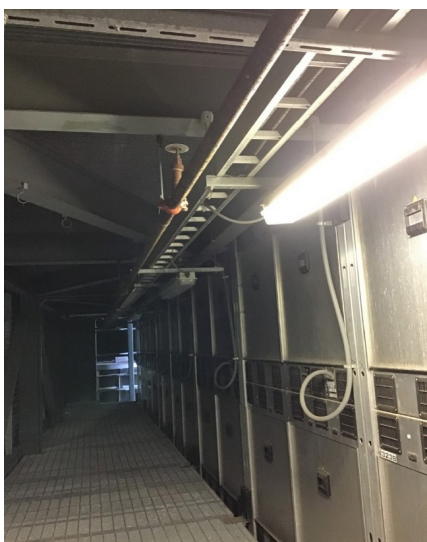
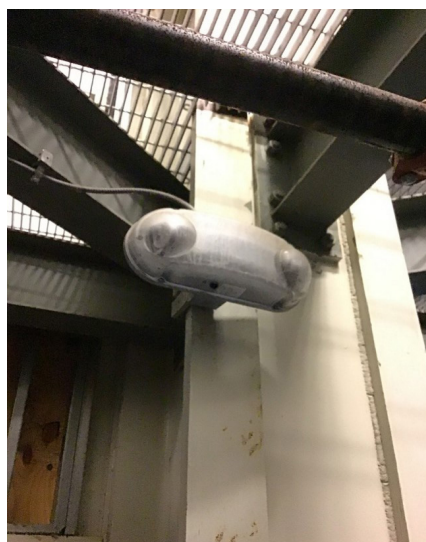
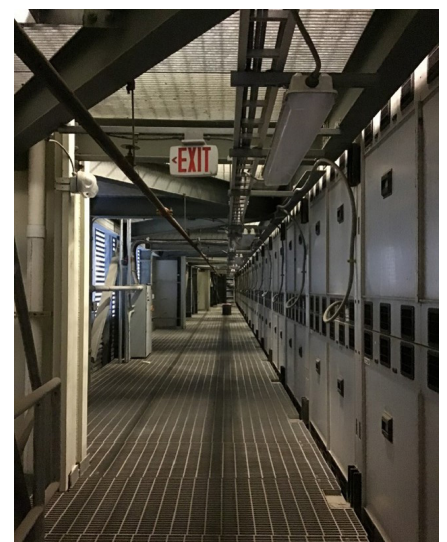
11. Floors behind score boards: All fixtures are industrial type fluorescent fixtures; most are still of T-12 origin. Some fixtures are completely dysfunctional, some are 50% operational. Some fixtures have damaged lenses or open/hanging. Emergency bug eyes and exit lights have no power and battery packs are drained. See Photos **E19, E20, E21 & E22.**
