# **2023 CAPITAL REPAIR AUDIT OF CLEVELAND BROWNS STADIUM FOR THE CITY OF CLEVELAND**

PREPARED BY OSBORN ENGINEERING

February 22, 2024

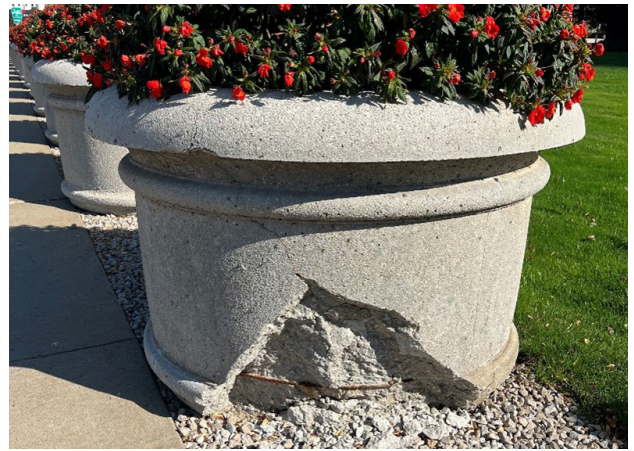
Photo L4 –Precast Concrete Planters

Several of the precast planters are beginning to crumble and will need to be replaced as an emergency repair (0-1 years). The remaining planters, which are beginning to crack, should be replaced within the 2-5-year window. The broken coping corners on the square planter planters create a safety hazard and should be replaced immediately (0-0 years). The broken planter curb should be done as an emergency repair (0-1 years).

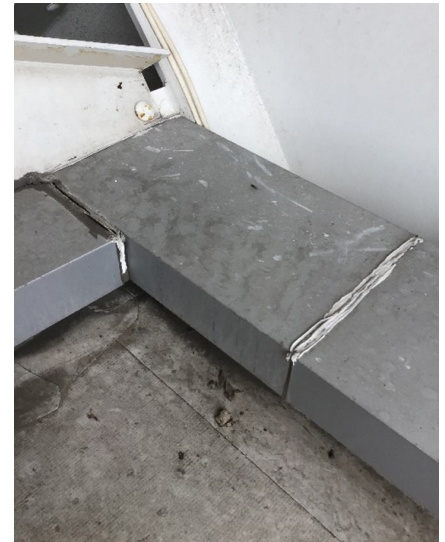
Photo A1 – Sealant Joints At Roof Parapet Cap.

The overall condition of the coping sealant joints at the roof copings and the granite panel bases are poor. Replacement with routine maintenance of the exterior sealant will be necessary to provide a continued long term watertight building.

Comprehensive replacement of joint sealant at base of exterior granite panels within 2-5 year time frame. Joint sealant replacement at failing roof coping locations within 2-5 year time frame with full replacement over majority of coping joint locations within 6-10 year time frame.

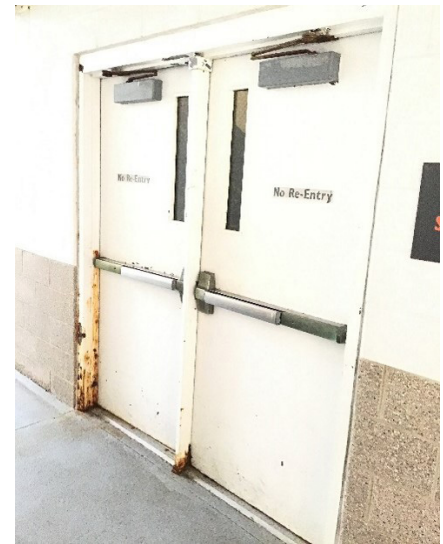
Photo A5 – Main And Upper Concourse Typical Fire Rated Door Assembly.

Photo A6 – Main And Upper Concourse Typical Fire Rated Door Assembly.

associated hardware should be replaced. Misaligned doors can be adjusted in the short term and do not need replacement. The fire rated exit door assemblies leading into the vertical exit enclosures are in fair to poor condition. Assemblies cannot function as intended. These doors are required to be self-closing, self-latching, and fully sealed per the Ohio Building Code. Damaged, non-conforming hardware should be replaced. New hardware will need be installed.

Replace damaged/improper functioning hardware on fire rated door assemblies immediately to satisfy building code requirements. Adjust door leafs to allow proper closing. At the Main, Club, and Upper Concourse levels, replace all hollow metal door assemblies with hardware over 2-5 year time period.

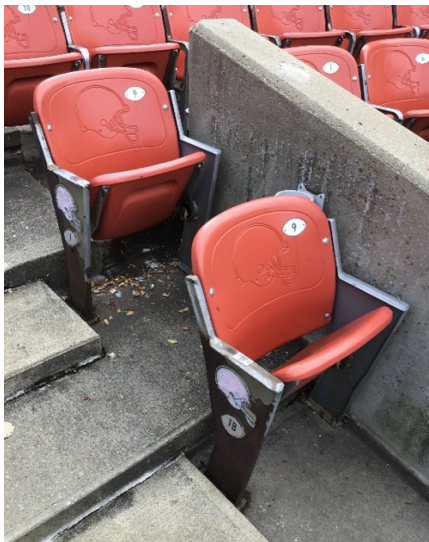
Seating in the Upper Bowl and Club Levels are in good condition. No rust or seat spring failure was observed. In the Lower Bowl sections, rust is present on standard feet and bases. Seat standards have spring failure. Fading of the seat color is clearly visible. Within the percentage of seats assessed, none were found to be loose from the concrete deck. Seating was secure. **See Photos A7 and A8.** Seating in the “Dawg Pound” area of the lower bowl level consists of aluminum bench seating, both new and old. Paint is in good condition. Seating was secure to concrete deck.

Photo A7 – Lower Bowl Seating

Photo A8 – Lower Bowl Seating

Replace seats within the Lower Bowl sections over 6 – 10 year time frame. Seating in the Upper Bowl areas should be monitored for rusting, spring failure, and bolt fastening to deck condition.

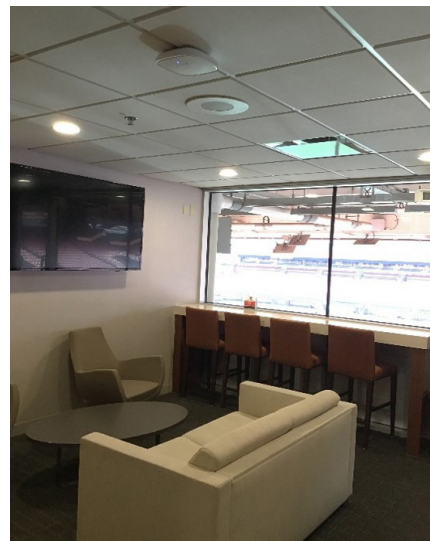
Photo A9 – Typical Suite.

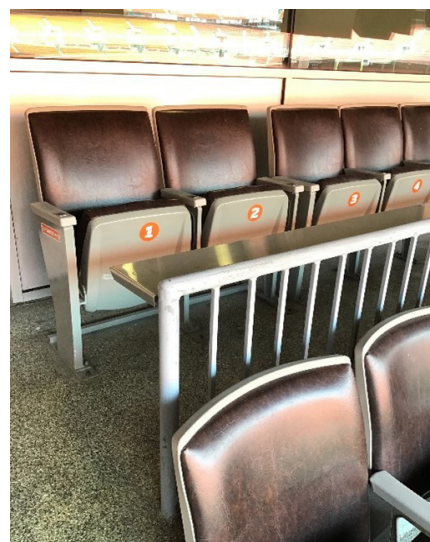
Photo A10 – Seating At Suite Balconies.

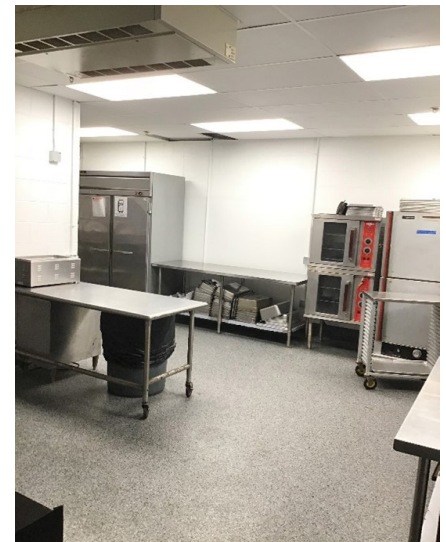
Photo A11 – Epoxy Floor In Kitchen Areas

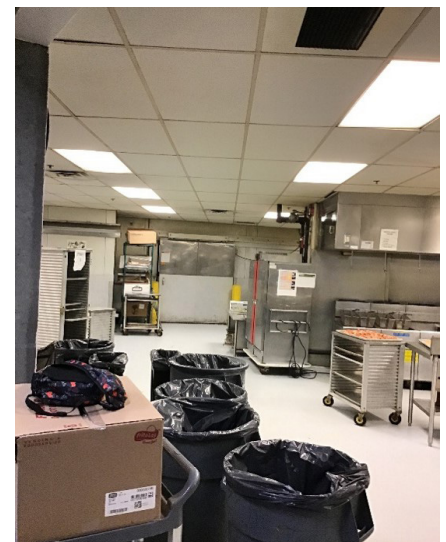
Photo A12 – Finish Ceiling In Kitchen Areas

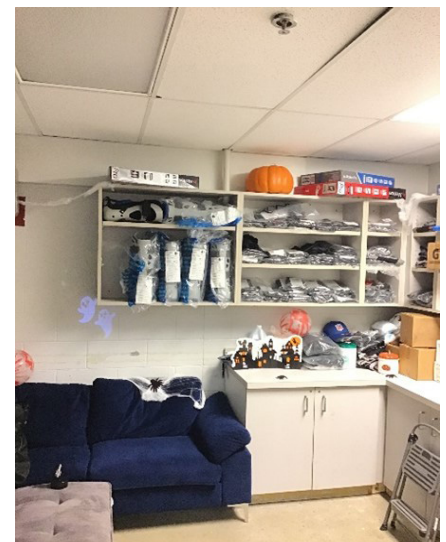
Continue routine maintenance of the food service areas to ensure current conditions.

Photo A13 – Wall And Ceiling Finishes, Service Level Office Area.

Photo A14 – Wall And Ceiling Finishes, Service Level Office Area.

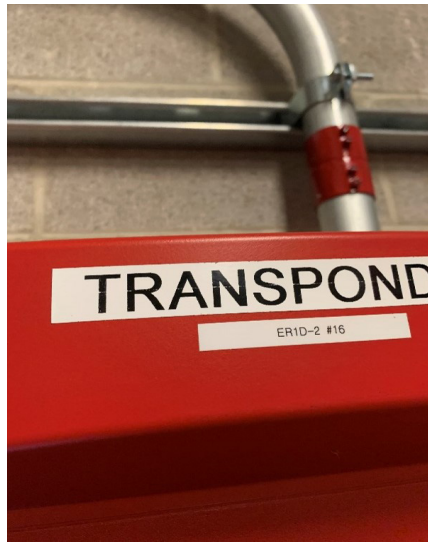
Photo FA1 – Quad D Level 200  
Transponder Panel

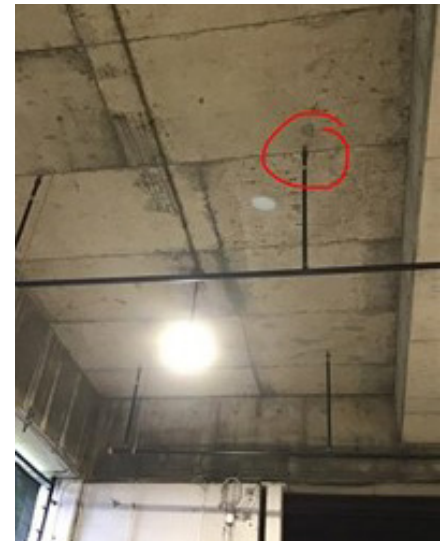
Photo FP4 – Services Drive  
Sprinkler Deflector Clearance

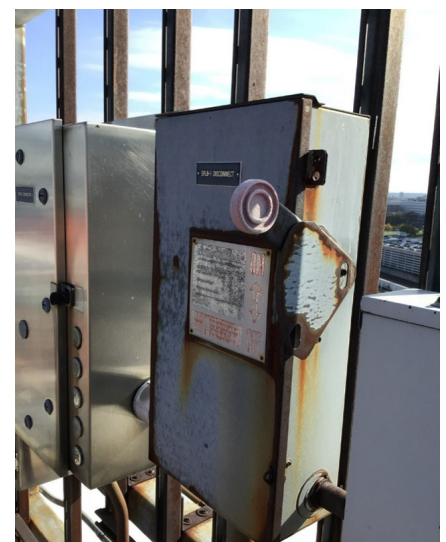
Photo E2 – Field Light Disconnect

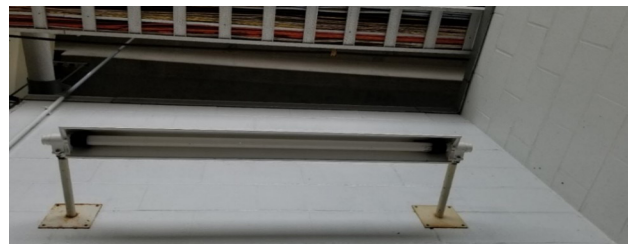
Photo E4 - Linear Fluorescent Fixture Mounted In Concourse.

fluorescent in 4 and 8 foot lengths. They run along the side of the concourse and are mounted over the niches at toilet rooms. Wall bracket types are mounted at the entrances to the vomitories. These all date from original construction and are in poor condition. **See Photo E4.**

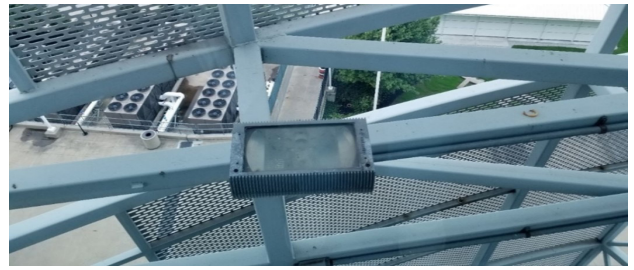
Photo E5 - Hid Fixture Mounted Behind Windscreen

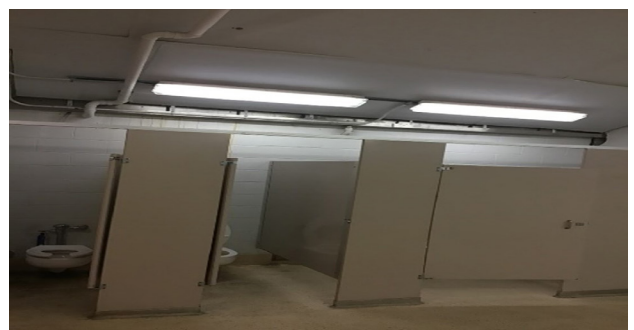
Photo E12 - Typical Toilet Room Wall Mounted Fluorescent Fixture.

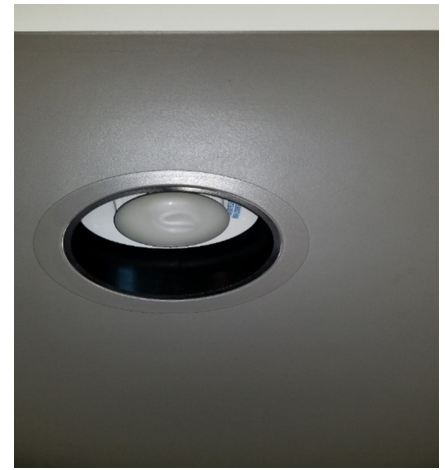
type fluorescent. **See Photo E13.** Again, the lighting is dated and energy inefficient, in particular the downlights need to be upgraded to LED.

Photo E13 - Typical Fluorescent Downlight.

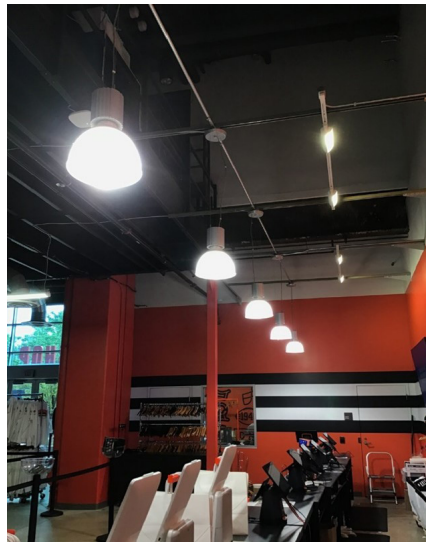
Photo E18 - Browns Store Lights

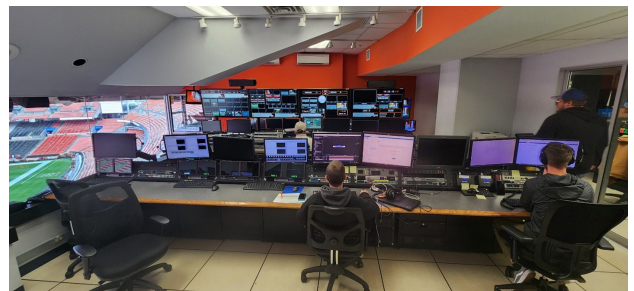
Photo B1 – Video/Scoreboard Control Room

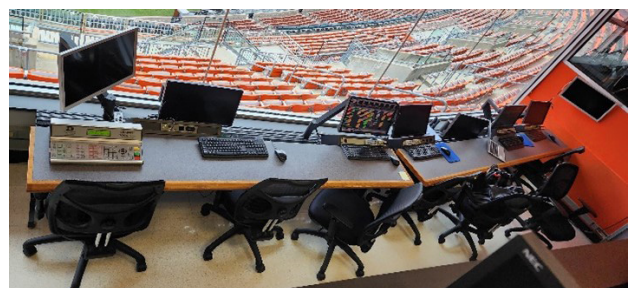
Photo B3 – Time/Score and Scoreboard Control

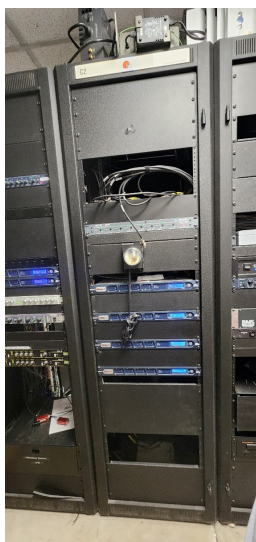
Photo B25 – BSS DSP's

The network technology that has been the basis of the networked audio is based on an older proprietary protocol of the DSP manufacturer. Additionally, the DSP supporting the audio system are reaching end of life. We recommend replacement of the DSPs with current product that supports industry standard network protocols such as AES67 or Dante. The staff have reported have recently begun using one of the newer standards-based protocols.

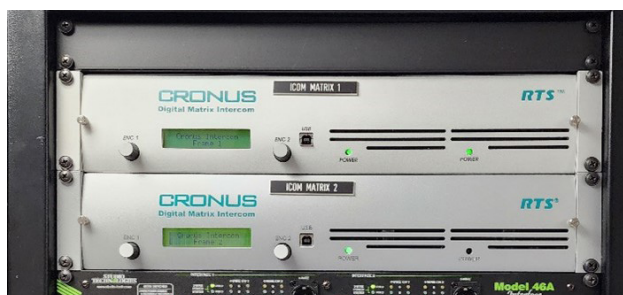
Photo B27 – RTS Intercom

The production intercom's local station panels are failing and will periodically requiring replacing by a refurbished panel, as the system is beyond end of life. Old panels being replaced are kept to for emergency parts only. As communications is a critical during game day, these systems failures create significant operational issues.
